MASTER UNIVERSITARIO EN CIENCIAS, TECNOLOGÍAS Y GESTIÓN AMBIENTAL

MASTER'S THESIS

Assessment of the environmental impact of tailings in the Republic of Armenia

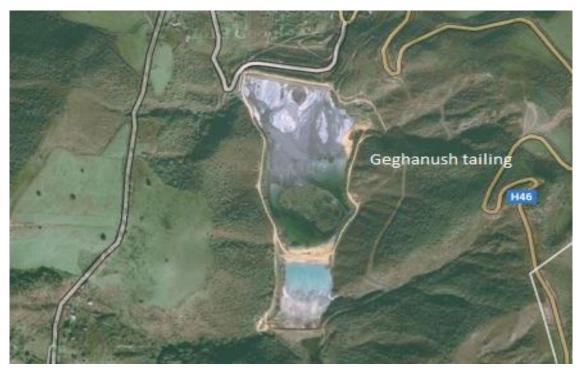
Figure 4. Aerial view of Geghanush tailing

Geghanush dam was built in the Geghanush river gorge. It was designed by the "Mekhanobr" design institute (Leningrad), and was put into operation in 1962 and closed in 1983. In this year, a new project was developed by "HayGunMet project" Institute, which planned to raise the dam by 10 m and to provide space for an additional volume of 4.1 million m³. The new tailings dam has a recirculation water system^[31].

Geghanush tailings dam (Figures 4 and 5) is located in the South of the Zangezur physiographic region, characterized by sharp mountainous relief. Morphologically, this region is situated in the offset of the Southern mountain range of Bargushat, and it is relatively low, with an altitude from 700 to 1250 m above the sea level^[32]. The relief is mountainous. The dominant vegetation is represented by grasses and bushes. The river valley of the upper stream runs through a narrow gorge with steep slopes. The relief of the watershed shows a complicated drainage network, with many streams and gorges.

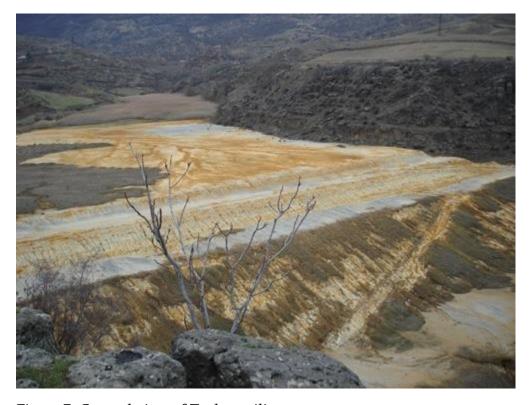
Figure 7. General view of Teghut tailing

According to the nature of factory productivity (output tails), the degree of liability structures, and the alluvium height, date of exploitation and volume, the tailings belongs to Class II. In order to reduce the accumulation of non-aggregated material in the surface of the tailing, reclamation includes the deposition of a soil layer with a thickness of 30 cm, where grasses are planted (Figure 7). The area of recultivation includes the slopes of alluvial levees performed during operation, and the shore area^[38].
